ASSESSMENT OF DAM SAFETY OF COAL COMBUSTION SURFACE IMPOUNDMENTS FINAL REPORT

**CPS Energy
J.K. Spruce Power Plant
San Antonio, Texas**

Prepared for
*U.S. Environmental
Protection Agency
Washington, D.C.*

February 2014
Revised May 2014
Revised June 2014

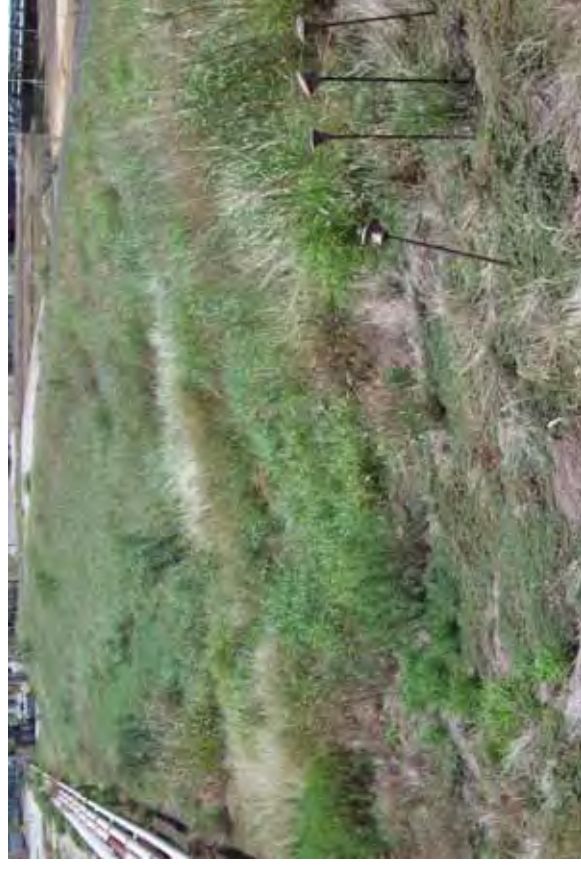
Photo 2: South embankment exterior slope, looking west.

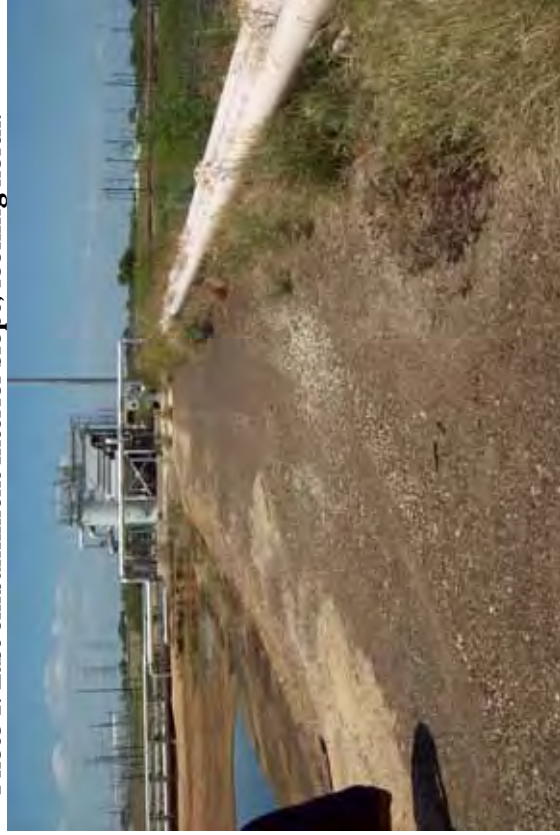
The crest of the SRH Pond appeared to be in satisfactory condition (Photographs 3, 13, 20, and 50). The crest was approximately 15 feet wide at all embankments except at the east embankment where it widened to approximately 50 feet to accommodate the clarifier pad (Photograph 8). Two spillways that connect the SRH and South Bottom Ash Ponds were located on the east embankment crest (Photographs 5 and 9). Supports for overhead piping were located at the west embankment crest (Photograph 22). The crest of the embankments consists of compacted granular soils and gravel and is exposed to minimal vehicle traffic. No depressions or evidence of settlement were observed on the crest.

Photo 3: East embankment crest, looking north.

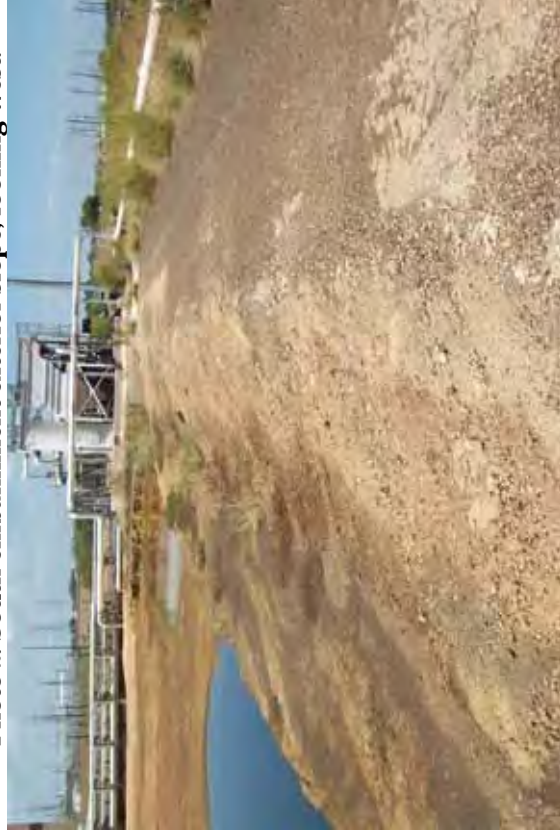
Interior slopes of the SRH Pond appear to be in fair condition (Photographs 4, 12, 14, 19, 45, and 51). Interior slopes were at 3H:1V and covered in a layer of granular material and other solids. Some sparse vegetation was observed in limited areas on the east and north embankment interior slopes (Photographs 4, 8, 9, and 17). Concrete roadway ramps into the pond for equipment access were located at the north and south embankment interior slopes (Photographs 17 and 53). Two spillway inlets were located on the east embankment interior slope (Photograph 7 and 11). Piping and sump pumps were located on a concrete pad built into the west embankment interior slope (Photograph 19 and 25). Visible portions of interior slopes did not include riprap or other armoring.

Photo 4: East embankment interior slope, looking north.

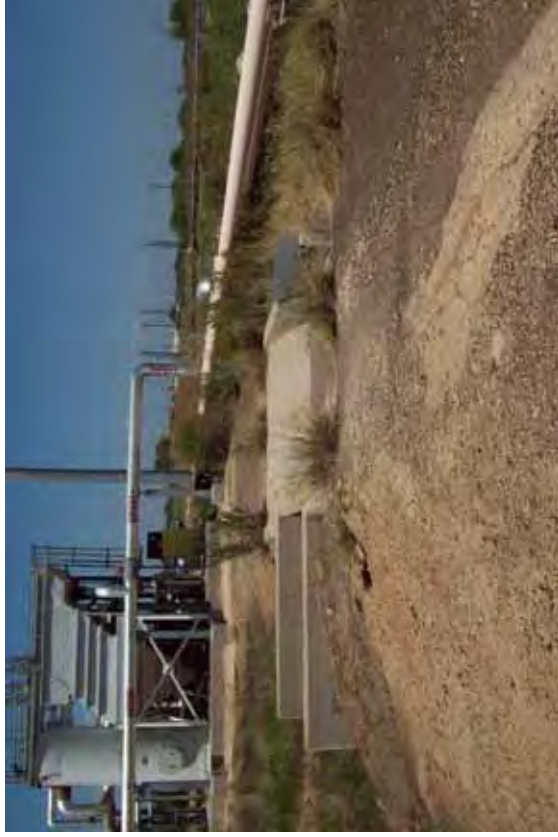
Photo 5: Spillway between SRH Pond and South Bottom Ash Pond at east embankment crest, looking north.

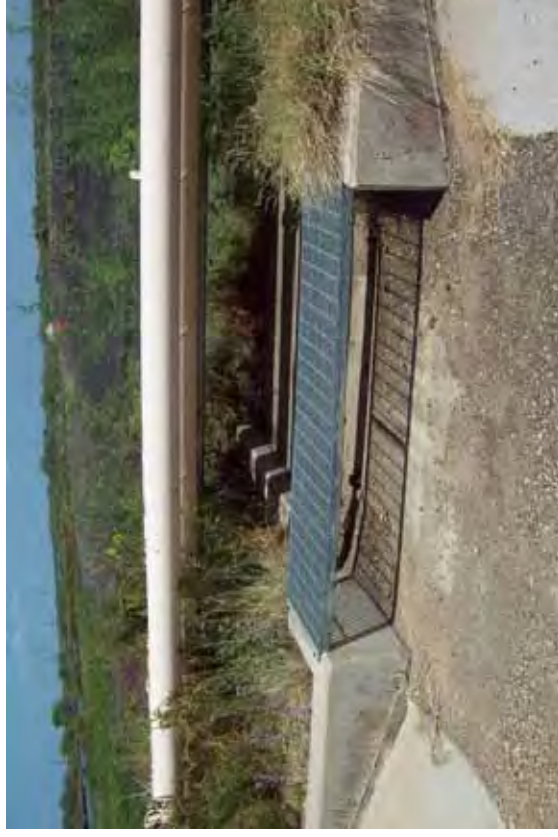
Exterior slopes of the SRH Pond appear to be in fair condition (Photographs 1, 15, 21, 46, and 52). The exterior slopes of the north, west, and south embankments are approximately 3H:1V and covered in grassy vegetation approximately 3 inches tall. The north embankment is shared with the #1 Stormwater Runoff Pond (Photograph 15). The east embankment is shared with the South Bottom Ash Pond and is covered in ash material and vegetation (Photographs 1, 6, and 10). Two spillway outlets were located on the east embankment exterior slope (Photograph 6 and 10). No areas of erosion or indications of seepage were observed at the spillways.

Photo 6: Spillway between SRH Pond and South Bottom Ash Pond at east embankment exterior slope, looking east.

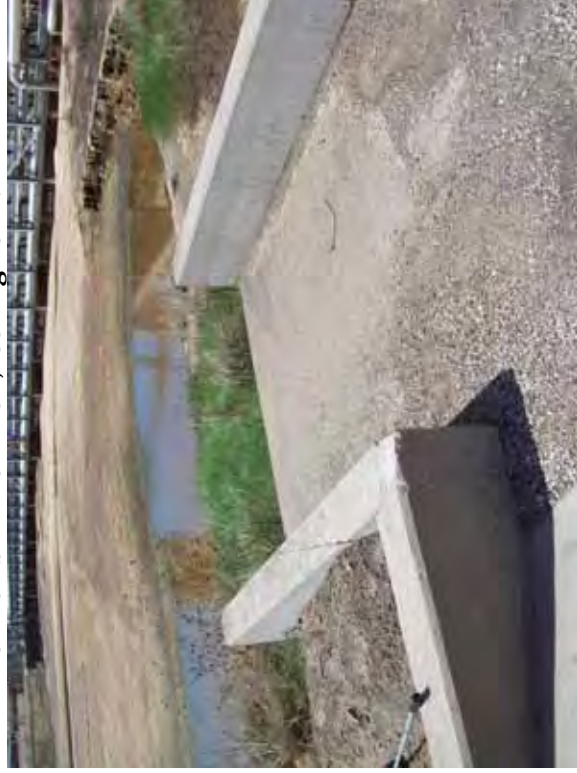
Photo 7: Spillway between SRH Pond and South Bottom Ash Pond at east embankment interior slope, looking west.

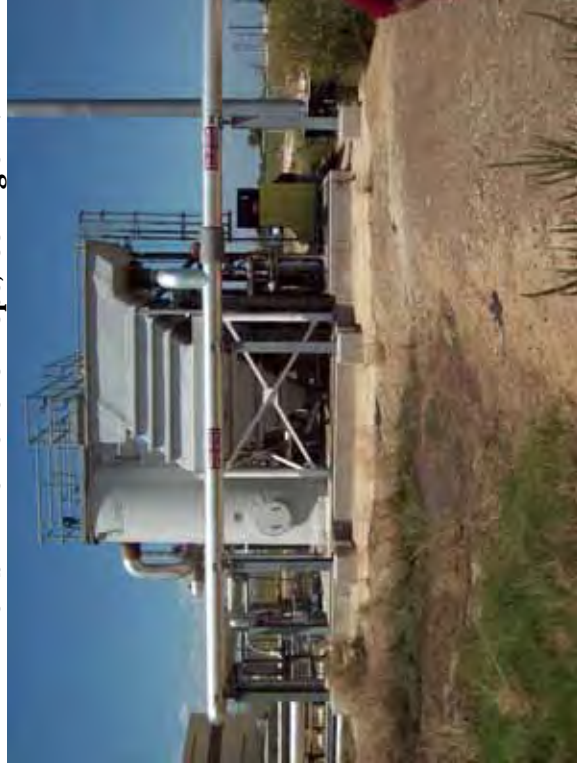
Photo 8: SRH Pond clarifier structure at east embankment crest, looking north.

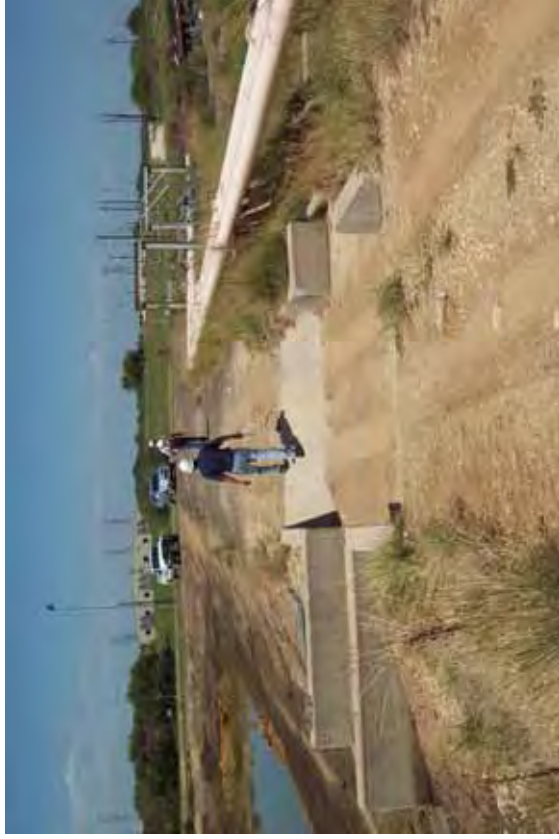
Photo 9: Spillway between SRH Pond and South Bottom Ash Pond at east embankment crest, looking north.

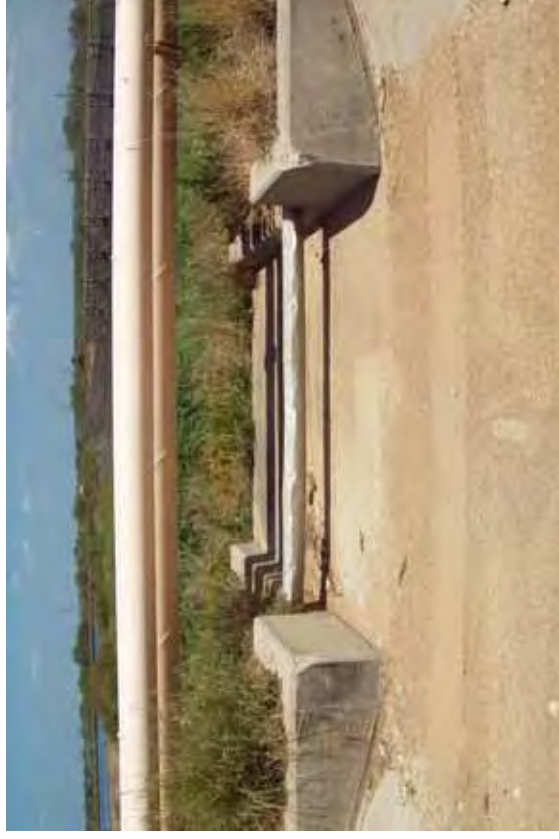
Photo 10: Spillway between SRH Pond and South Bottom Ash Pond at west embankment exterior slope, looking east.

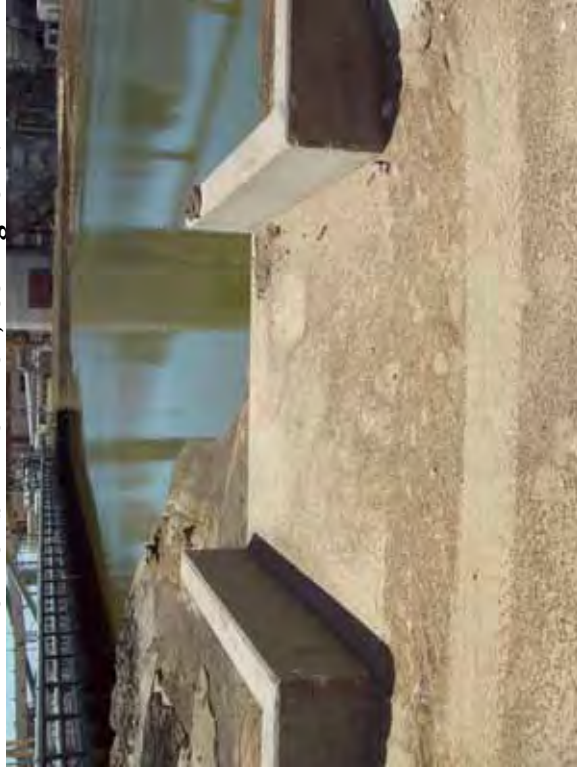
Photo 11: Spillway between SRH Pond and South Bottom Ash Pond at east embankment interior slope, looking west.

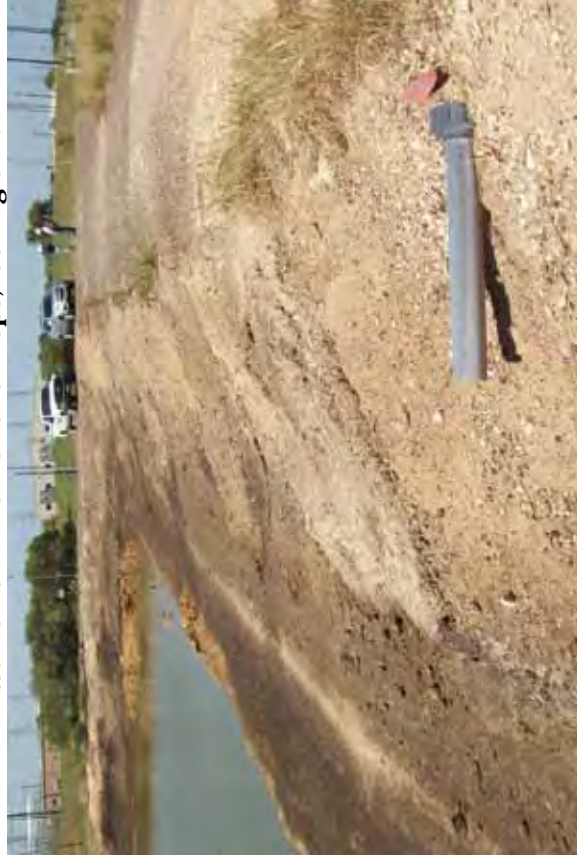
Photo 12: East embankment interior slope, looking north.

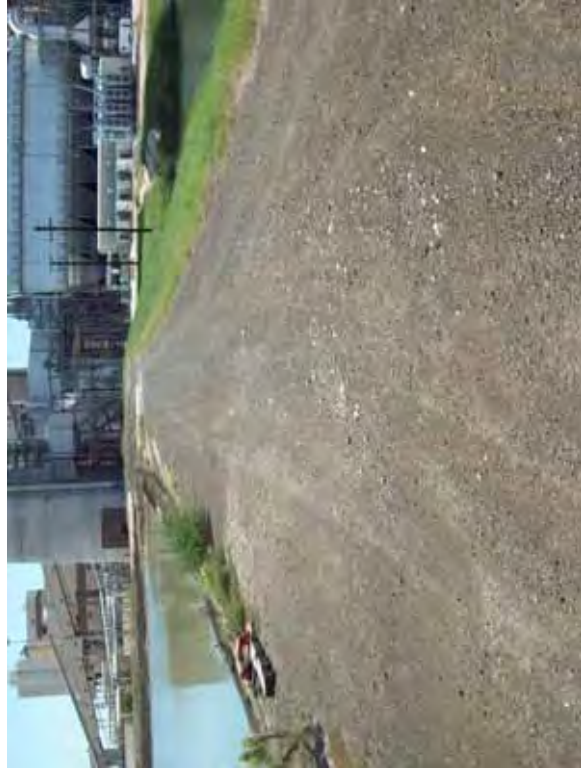
Photo 13: North embankment crest, looking west.

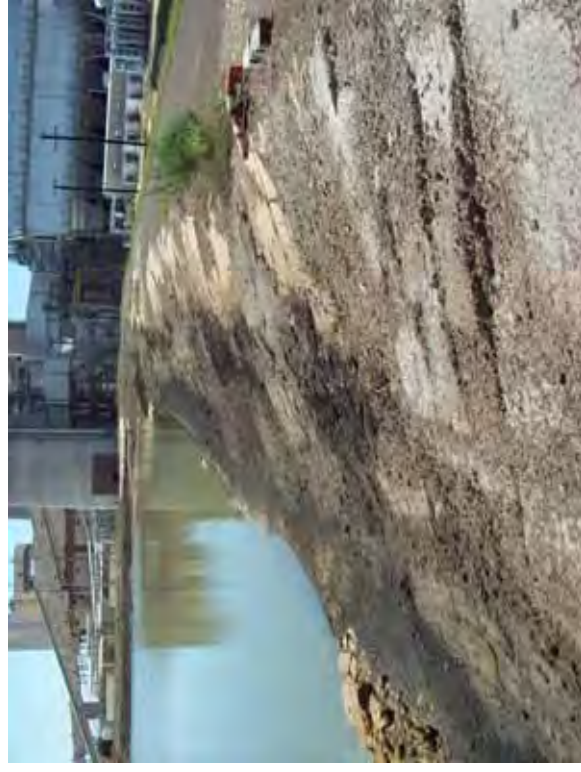
Photo 14: North embankment interior slope, looking west.

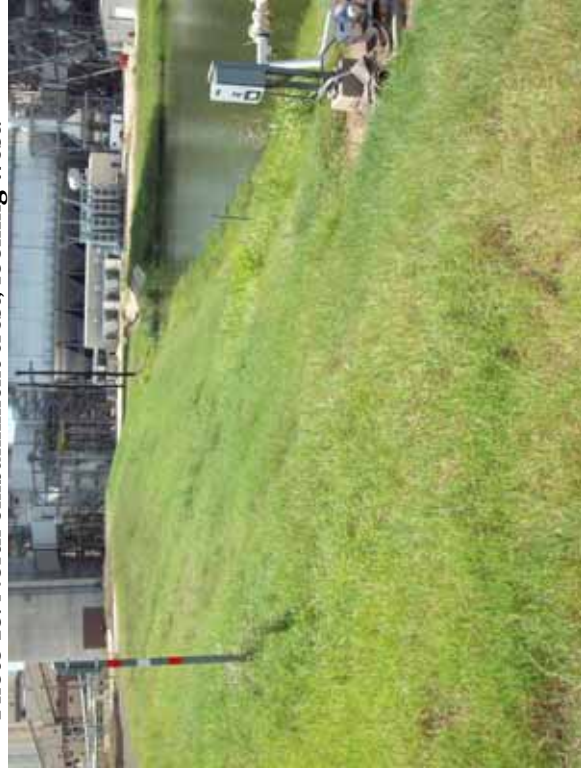
Photo 15: North embankment exterior slope, looking west. #1 Stormwater Runoff Pond at exterior toe.

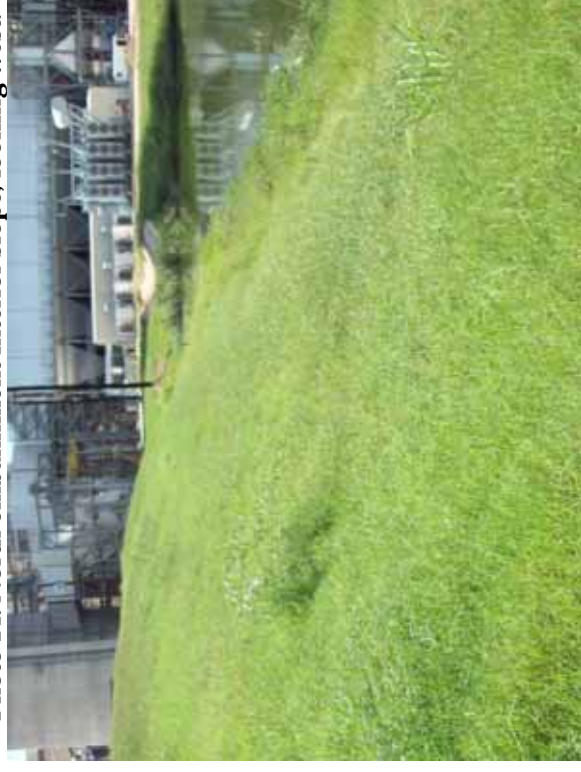
Photo 16: North embankment exterior slope, looking west.

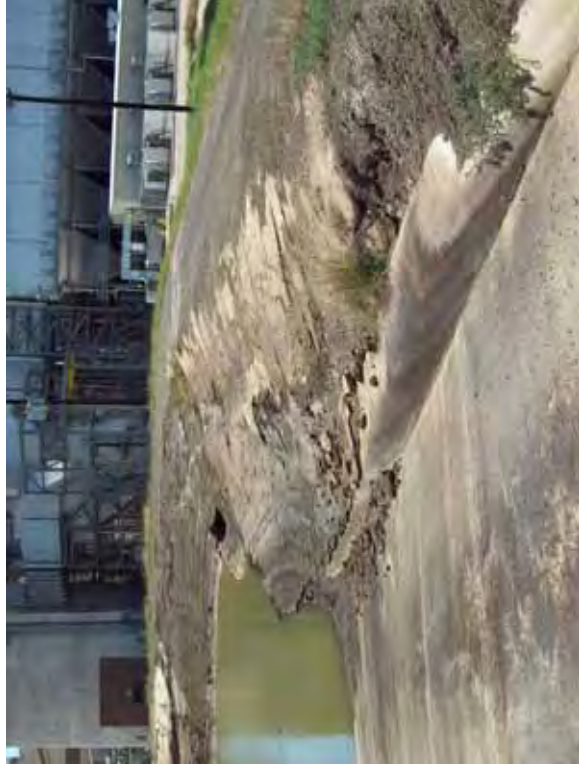
Photo 17: North embankment interior slope, looking west.

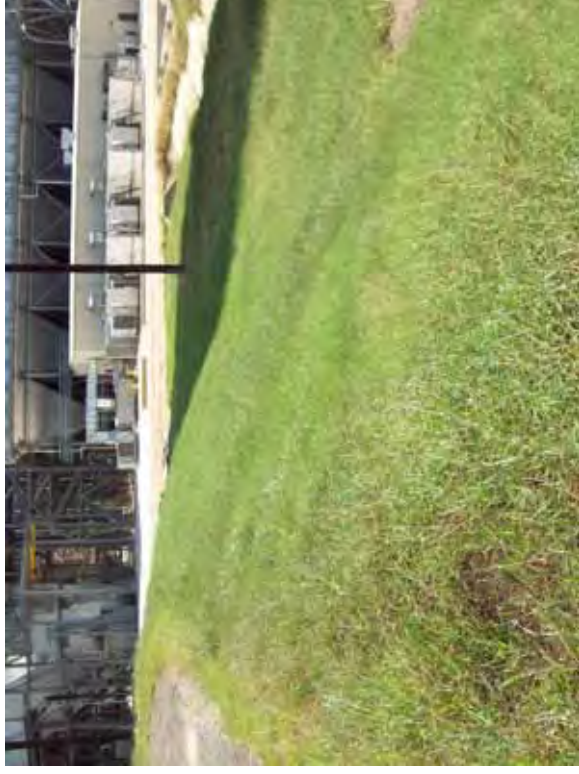
Photo 18: North embankment exterior slope, looking west.

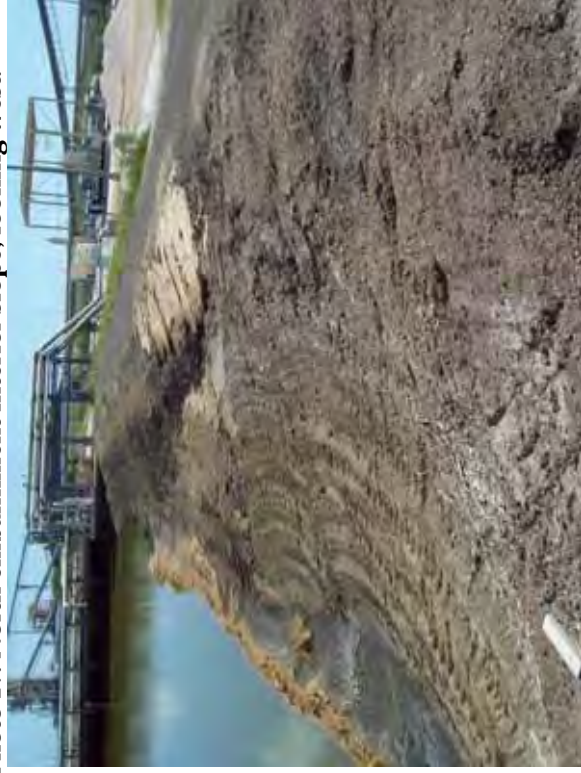
Photo 19: West embankment interior slope, looking south.

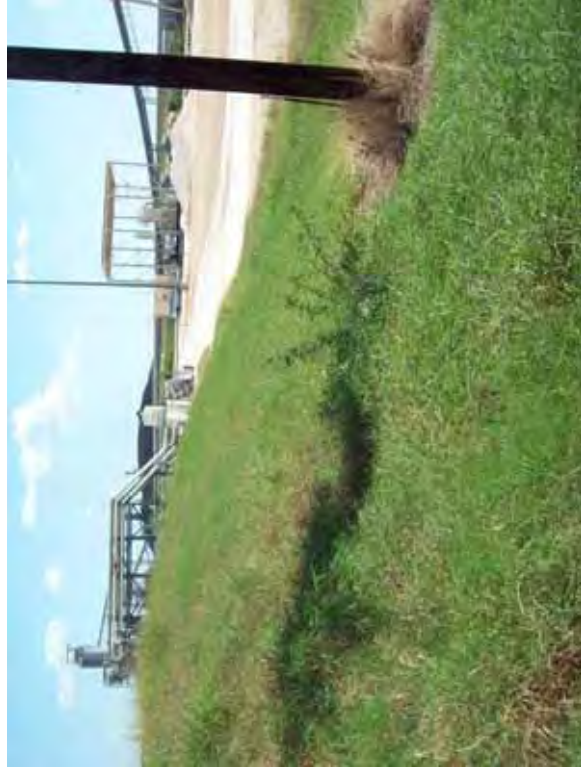
Photo 21: West embankment exterior slope, looking south.

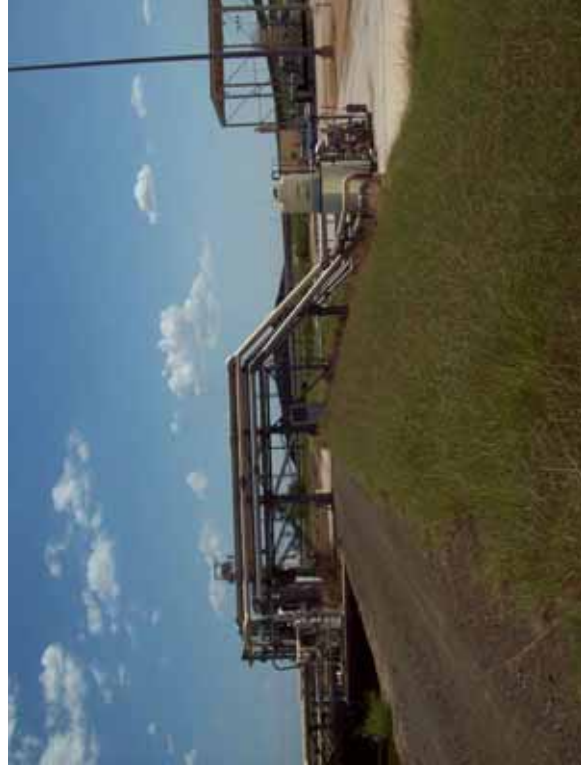
Photo 22: West embankment exterior slope, looking south.

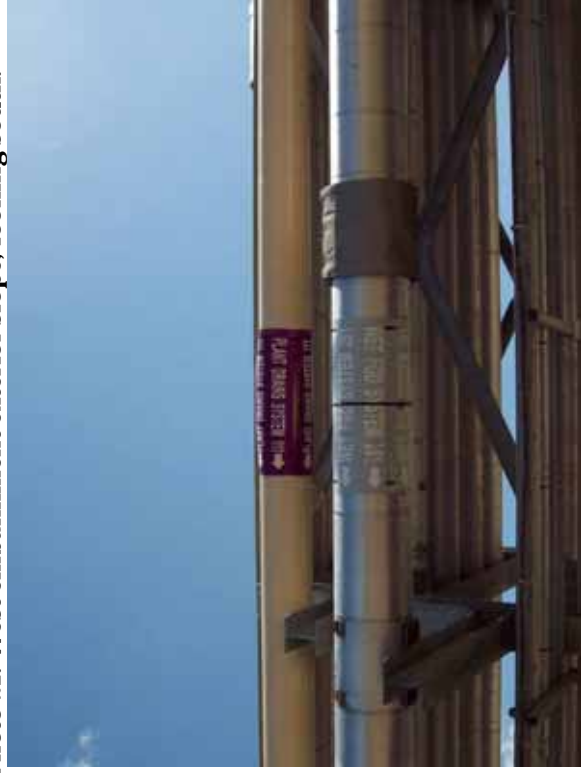
Photo 23: Overhead piping at west embankment crest, looking south.

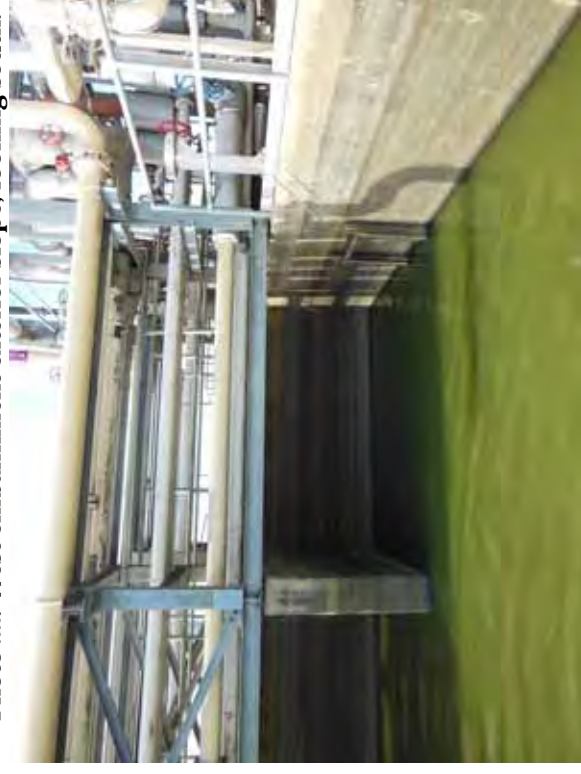
The outlet structure near the west embankment interior slope consists of two 18-inch-diameter steel outlet pipes, one is located in the north section of the pond and one is in the south section. The outlet pipes were submerged during the site assessment (Photographs 24 and 27). CCW is pumped through the outlet pipes to the clarifier located at the east embankment crest (Photograph 8). Liquids from the clarifiers are discharged to outfall 109 at the Plant intake canal (Photographs 55, 56, and 57).

Photo 24: Submerged SRH-north outlet structure at west embankment interior slope, looking south.

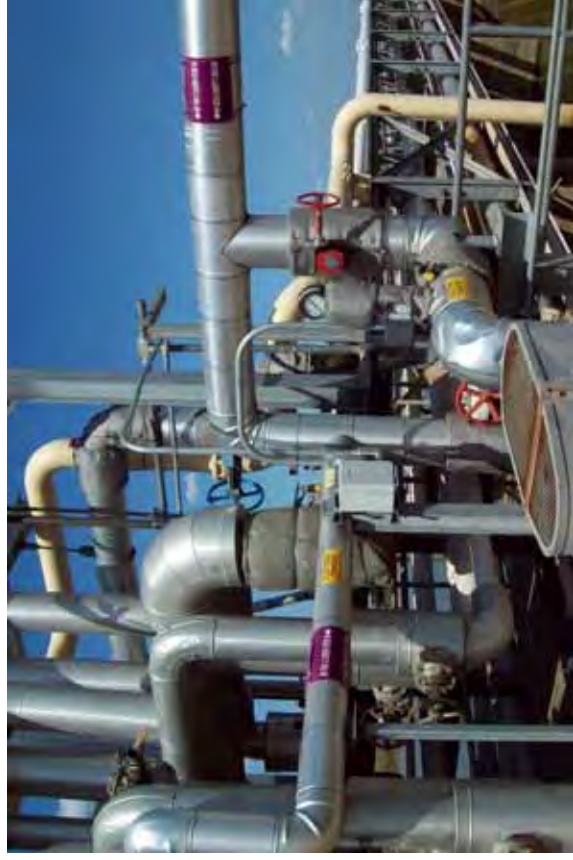
Photo 25: Piping at west embankment interior slope, looking northeast.

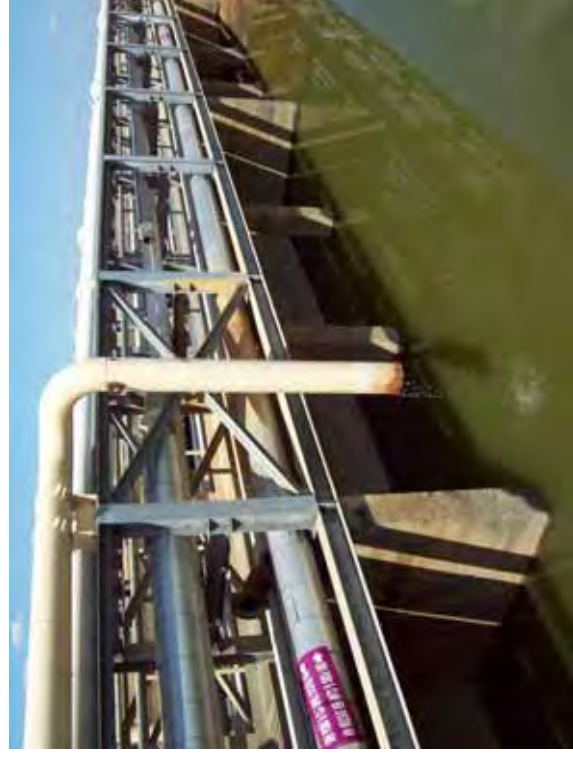
Several inlet pipes discharge liquids near into the north section of the SRH Pond; four 4-inch-diameter, eight 6-inch-diameter and two 8-inch-diameter metal pipe (Photographs 33, 38, 39, 40, 41, 42, 43, and 44). Inlet pipes discharging liquids into the south section of the SRH Pond include; four 4-inch-diameter, eight 6-inch-diameter and two 8-inch-diameter metal pipe (Photographs 26, 28, 30, 31, 32, 34, 35, 36, and 37).

Photo 26: 8-inch-diameter metal SRH-south inlet pipe labeled "Plant Drain System III", looking northeast.

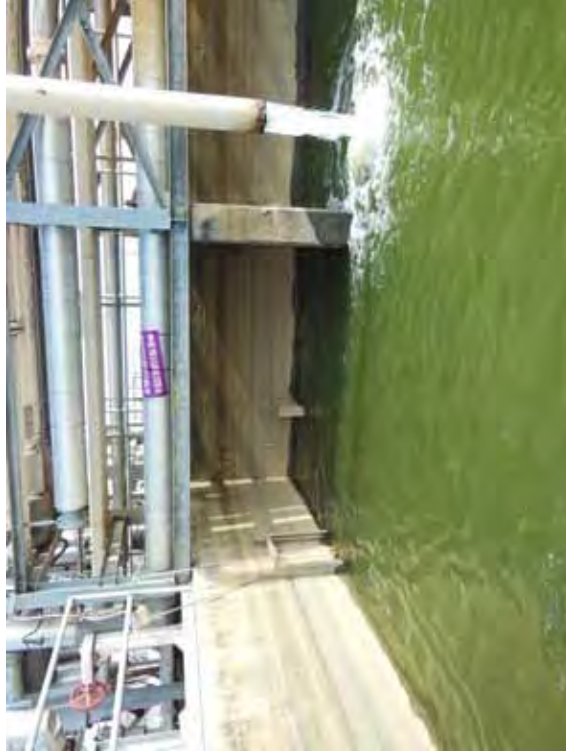
Photo 27: Submerged SRH-south outlet structure at west embankment interior slope, looking north.

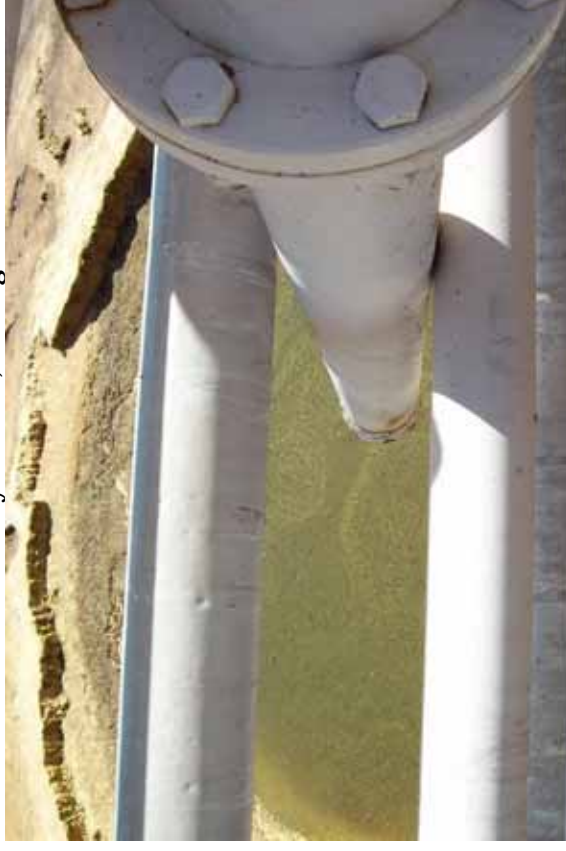
Photo 28: 6-inch-diameter metal SRH-south inlet pipe labeled "Waste Slurry Sump", looking south.

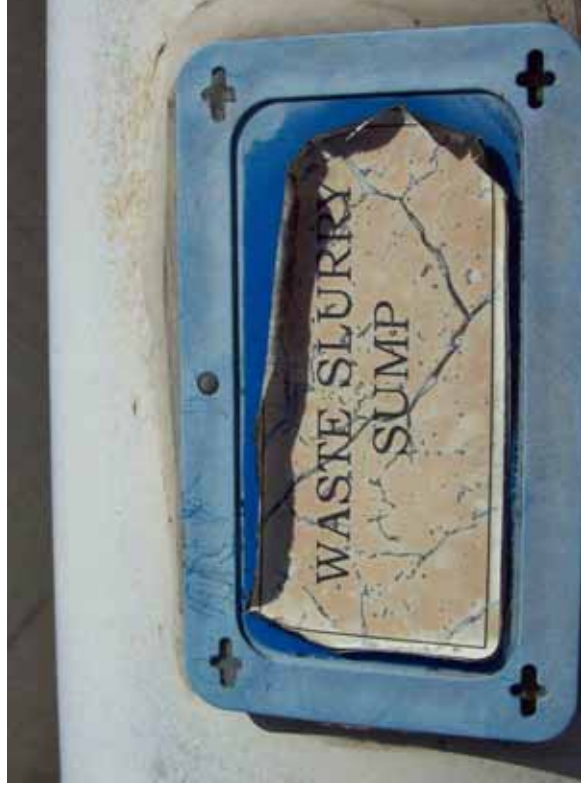
Photo 29: Label for inlet pipe in Photo 28.

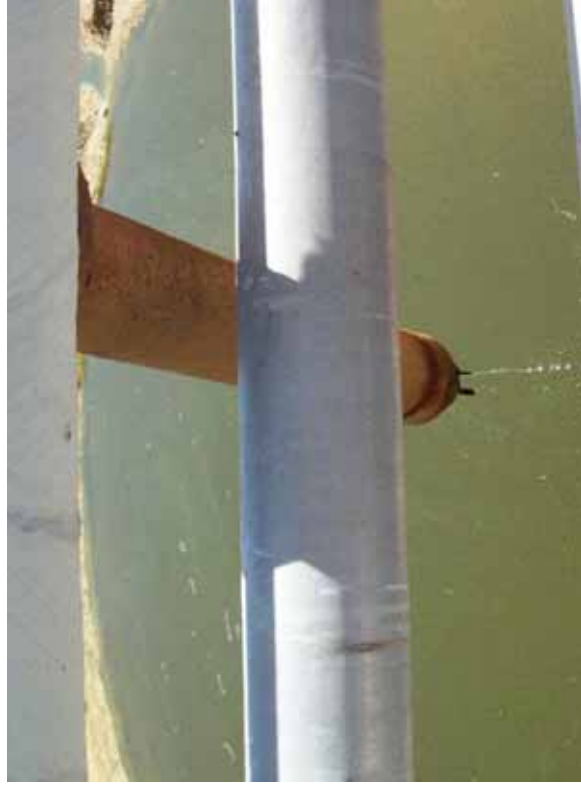
Photo 30: 6-inch-diameter metal SRH-south inlet pipe, looking south.

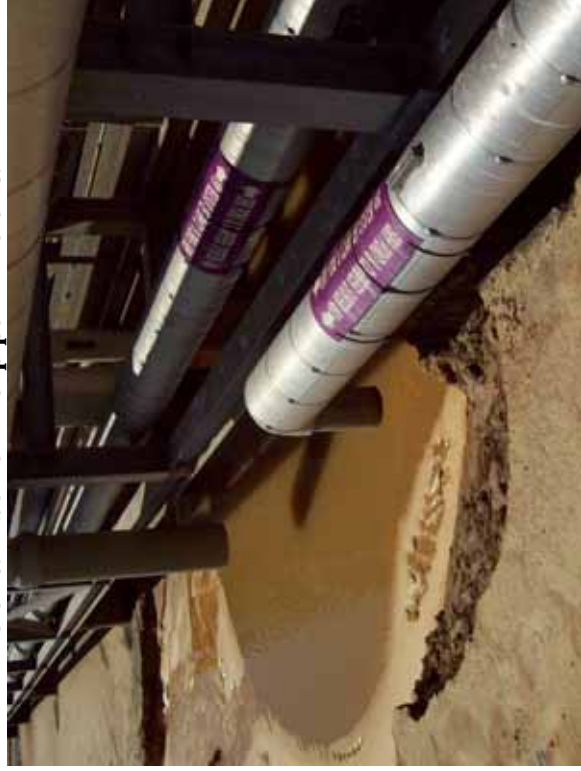
Photo 31: 6-inch-diameter SRH-south inlet pipe labeled "SRH Pond & Clarifier Syst 464", looking west.

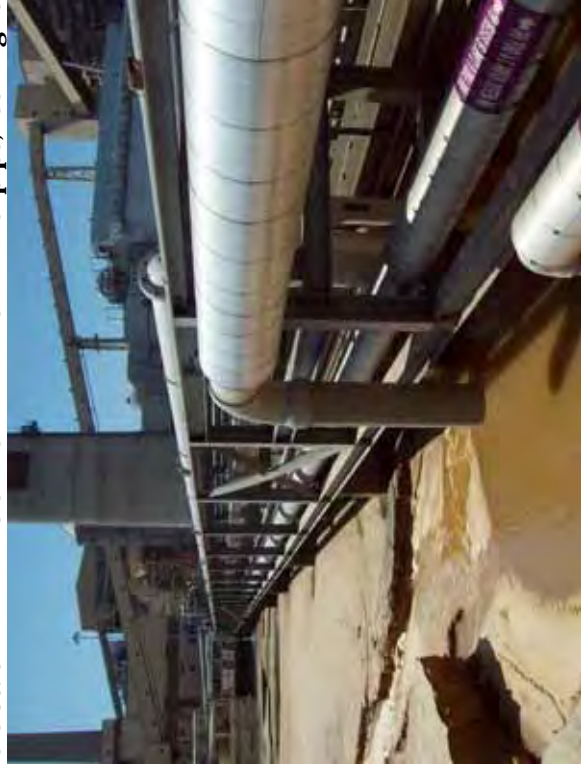
Photo 32: 8-inch-diameter SRH-south inlet pipe labeled "SRH Pond & Clarifier Syst 464", looking west.

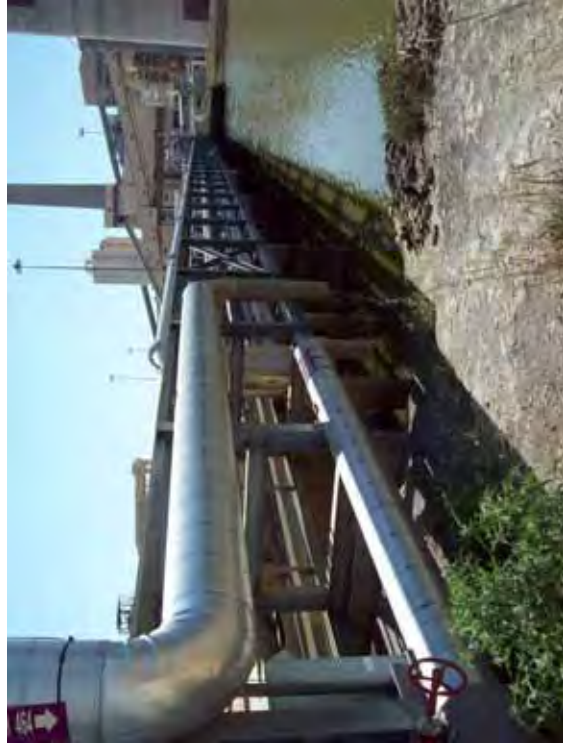
Photo 33: 6-inch and 8-inch-diameter SRH-north inlet pipe labeled “SRH Pond & Clarifier Syst 464”, looking west.

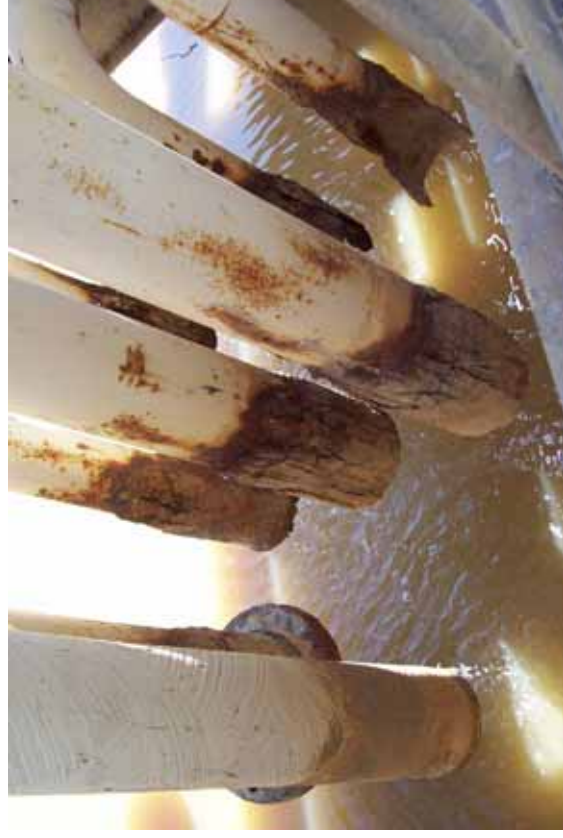
Photo 34: Nine outlet pipes into SRH-south, looking south.

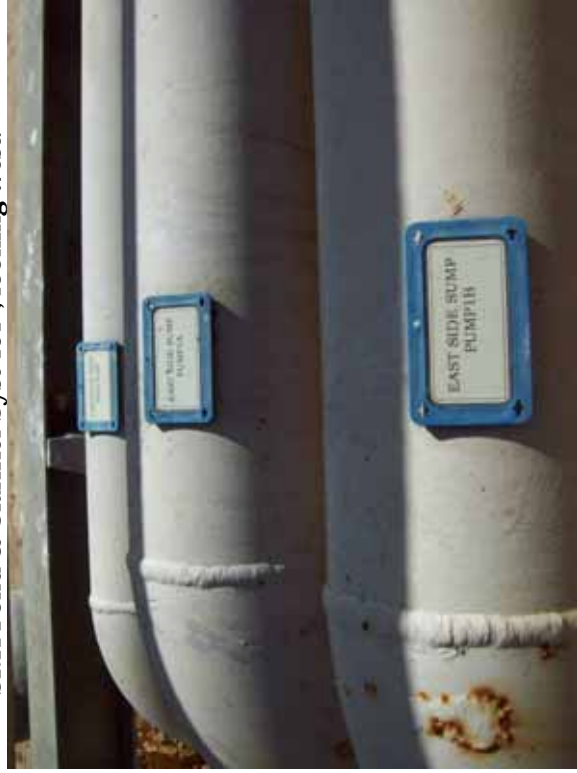
Photo 35: Labels for middle three 6-inch-diameter inlets shown in Photo 34.

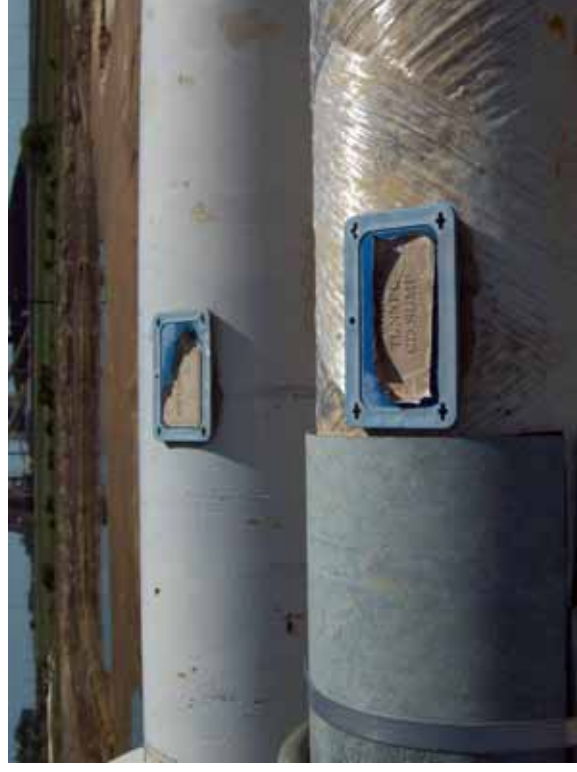
Photo 36: Labels for left two 6-inch-diameter inlets shown in Photo 34.

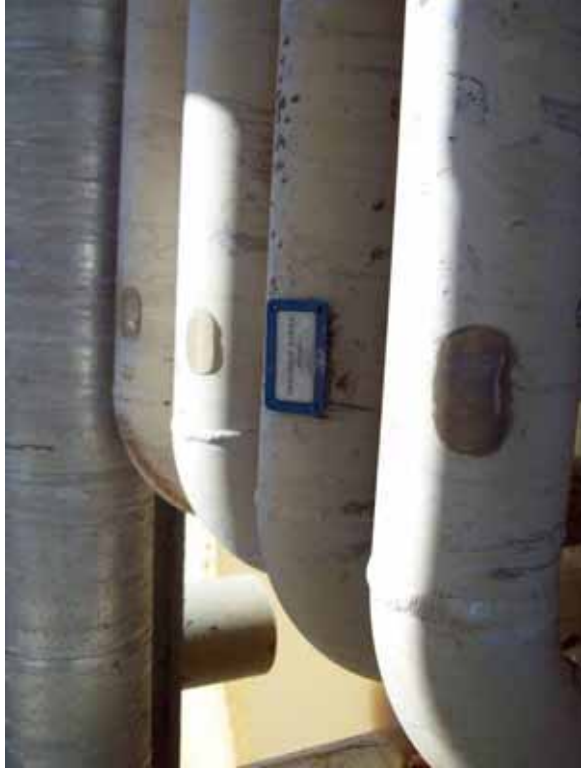
Photo 37: Labels for right four 4-inch-diameter inlets shown in Photo 34.

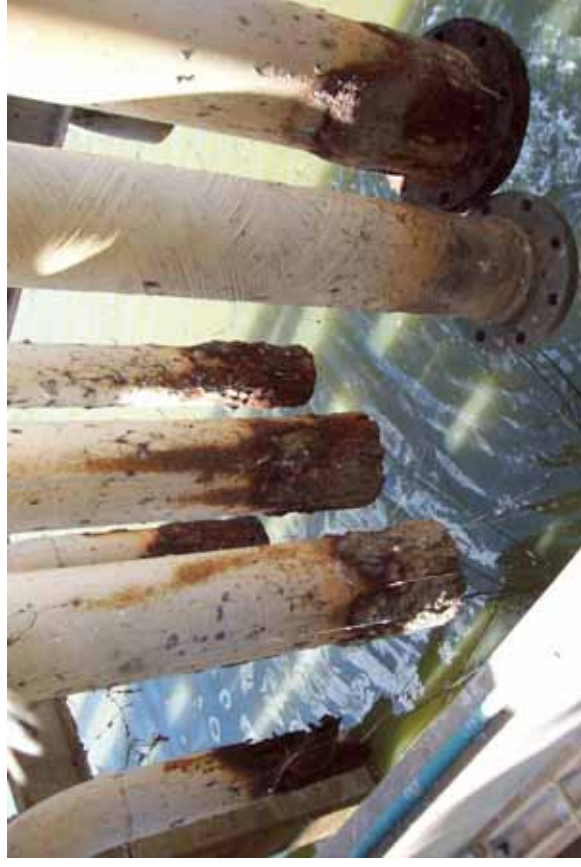
Photo 38: Nine outlet pipes into SRH-north, looking north.

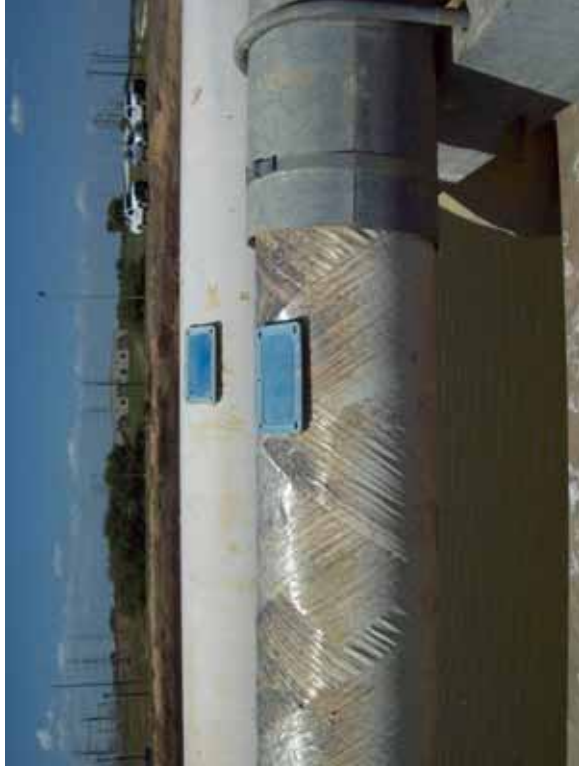
Photo 39: Labels for right two 6-inch-diameter inlets shown in Photo 38.

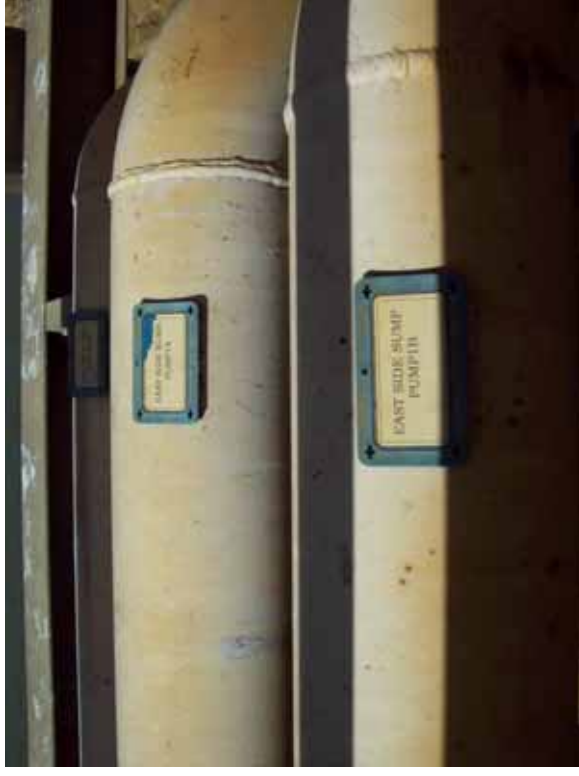
Photo 40: Labels for middle three 6-inch-diameter inlets shown in Photo 38.

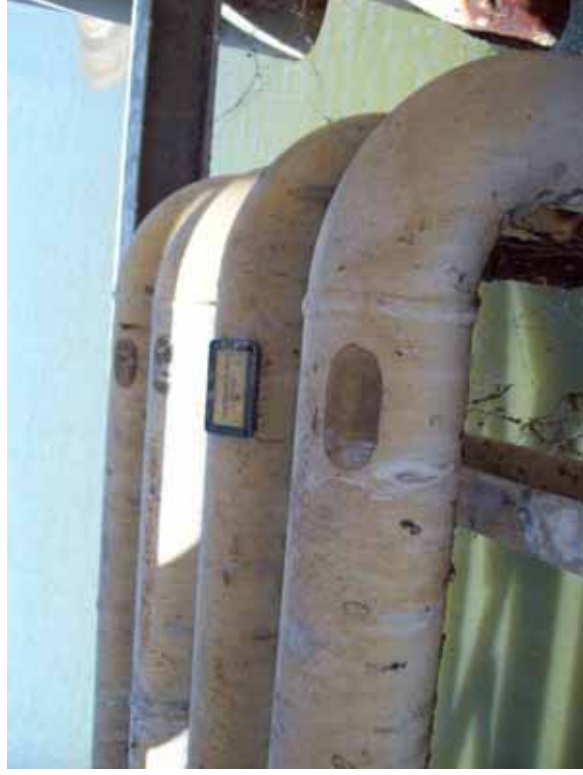
Photo 41: Labels for left four 4-inch-diameter inlets shown in Photo 38.

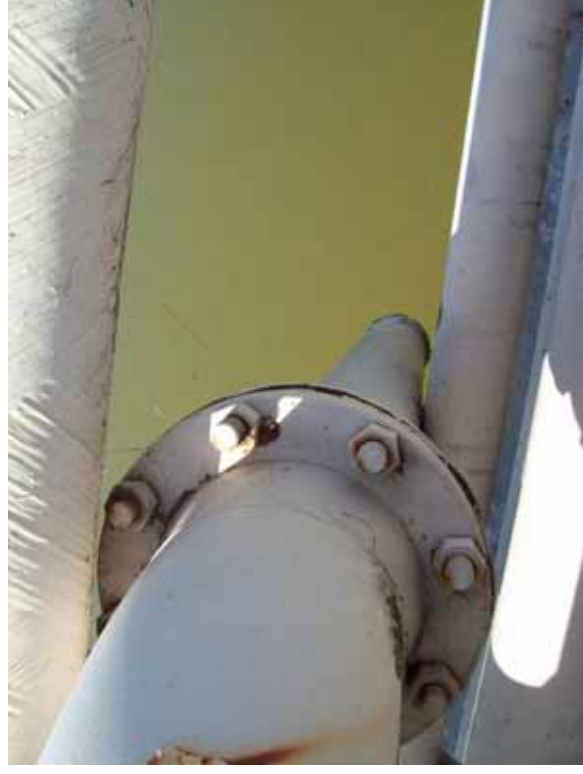
Photo 42: 6-inch-diameter metal SRH-north inlet pipe labeled "Waste Slurry Sump", looking north.

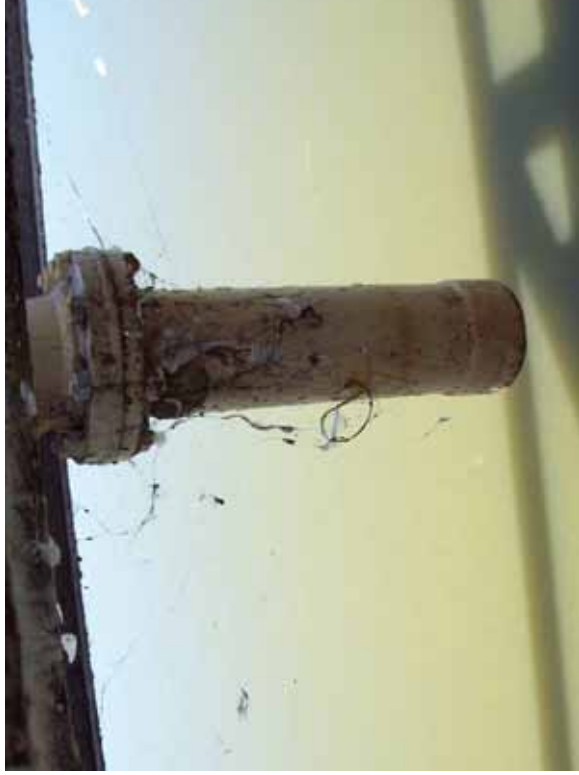
Photo 43: 6-inch-diameter metal SRH-north inlet pipe, looking north.

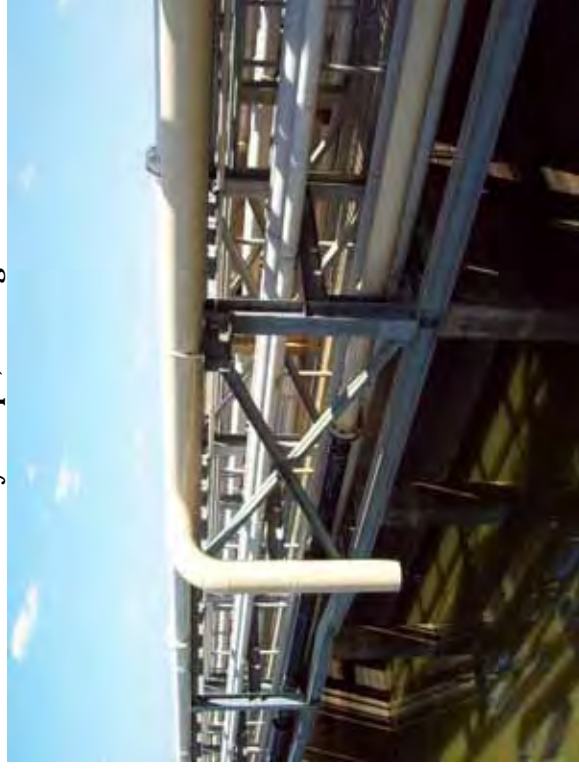
Photo 44: 8-inch-diameter metal SRH-north inlet pipe labeled "Plant Drain System III", looking southeast.

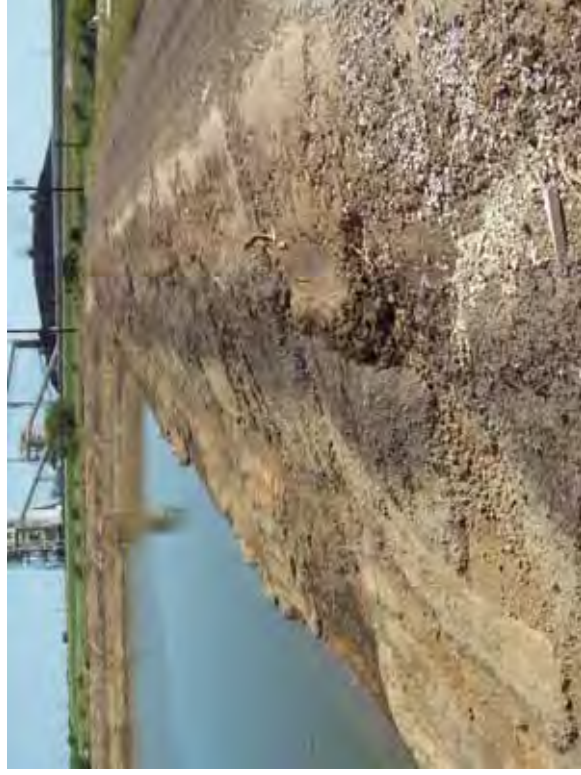
Photo 45: West embankment interior slope, looking south.

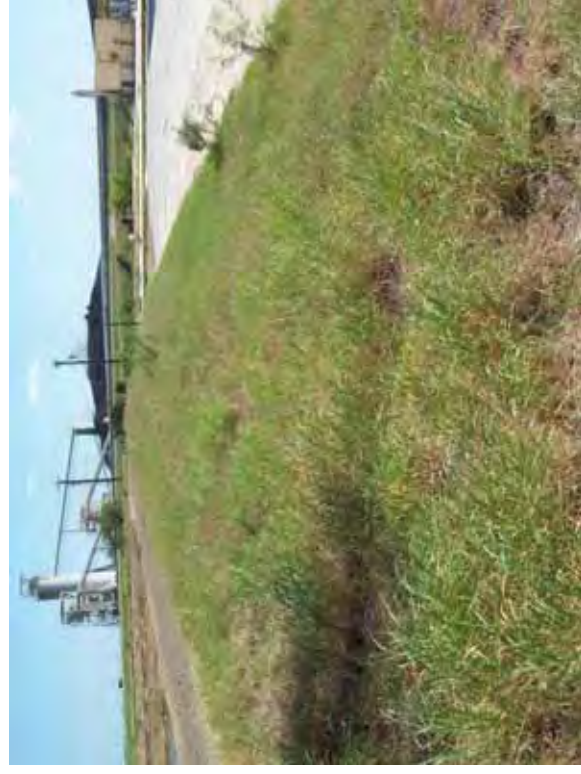
Photo 46: West embankment exterior slope, looking south.

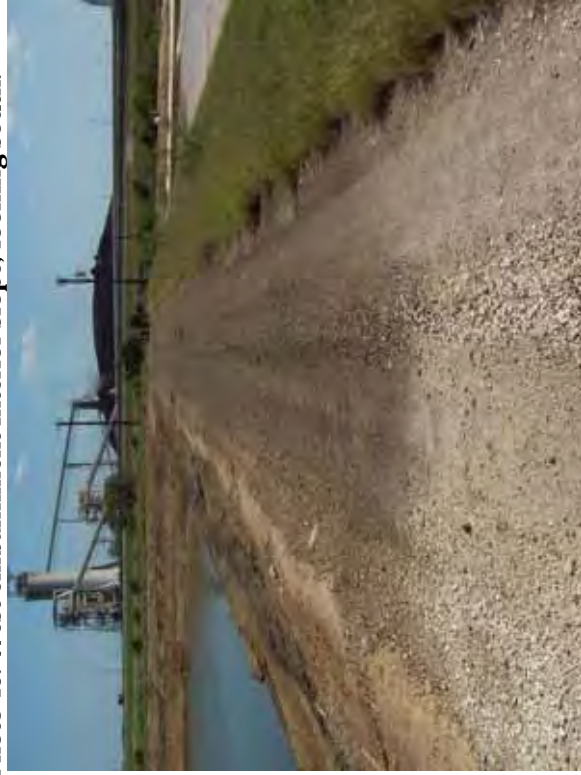
Photo 47: West embankment crest, looking south.

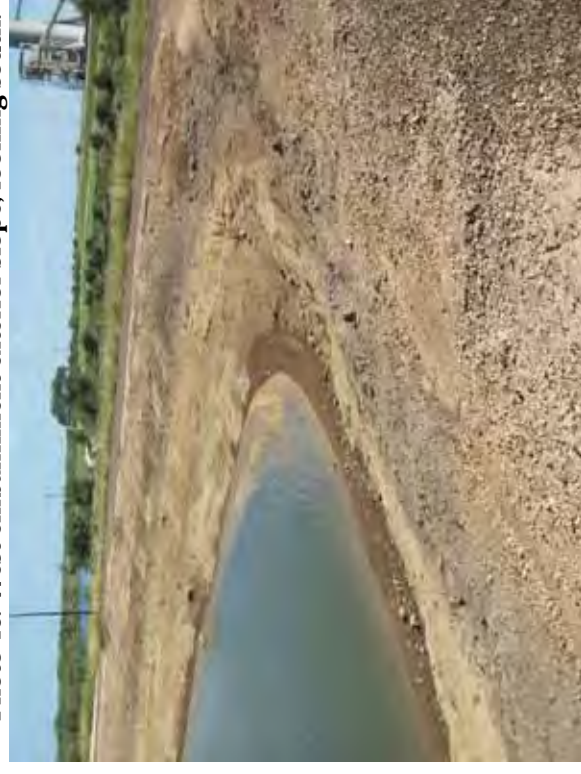
Photo 48: Interior slope at southwest corner interior slope, looking southeast.
